Photographs of a UNICEF School Building Programme in Vietnam (1072 classrooms).

UNICEF School Building Programme in Vietnam (1072 classrooms).

Photos from the erection of the prototype building
in Hai Phong September-October 1977.

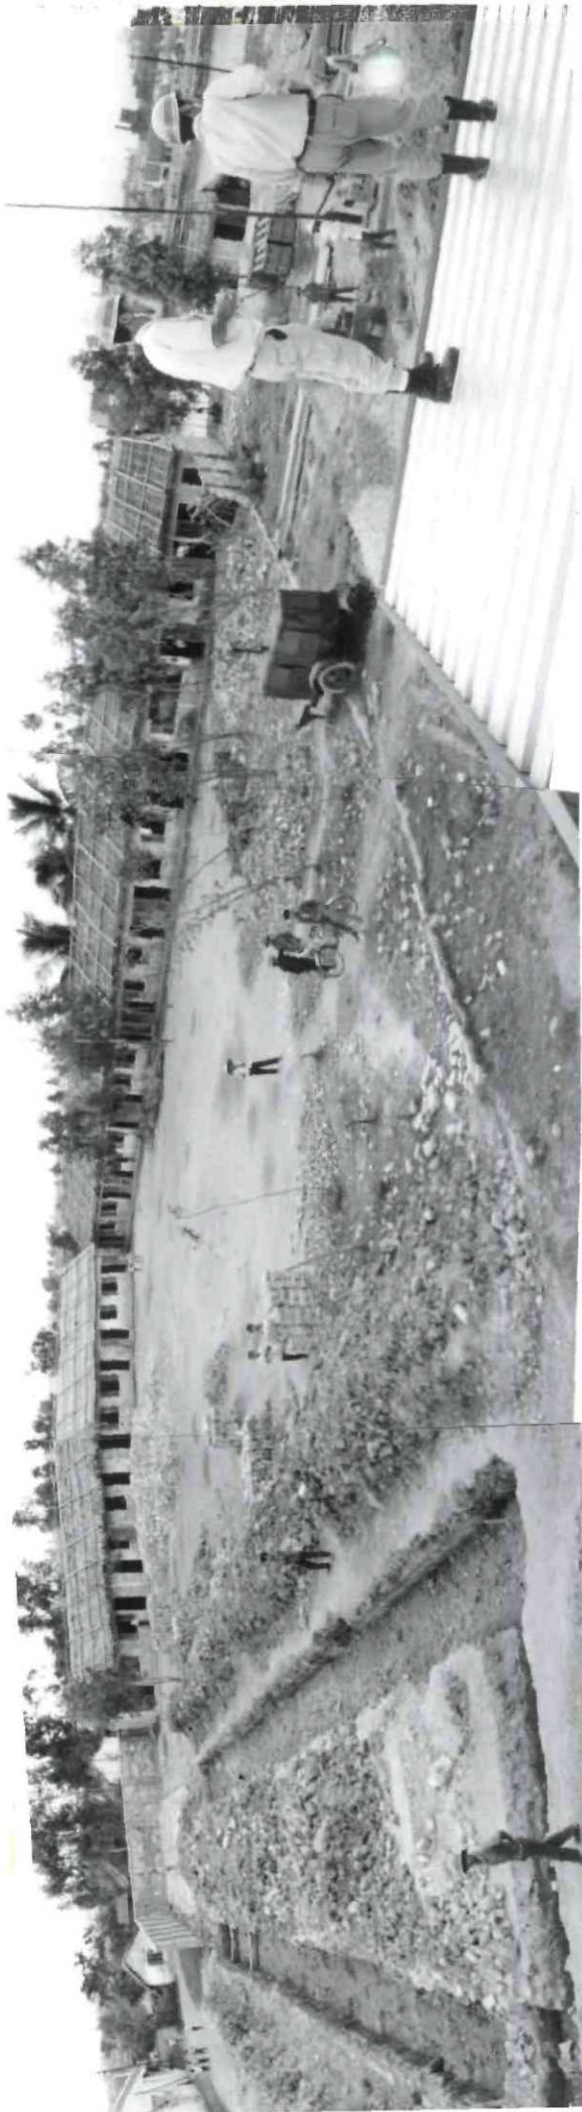
-1-

Top: View over the western half of the site taken from the first floor of the prototype building. To the left, the foundation for the second building is being prepared. The one-storey buildings are being used as primary schools. Education is given in three shifts, seven days a week, to overcome the extreme shortage of classrooms in the area. They are planned to be improved later. To the extreme right, behind Mr Orihara and Mr Yamamoto, the ground for the third building at this site can be seen. A temporary, one storey school has just been cleared away since it was damaged beyond repair by the hurricanes last September.

Left: Site plan. The three UNICEF-supported buildings are marked with "1". The prototype is situated bottom right. The point from which the photo above was taken is indicated.

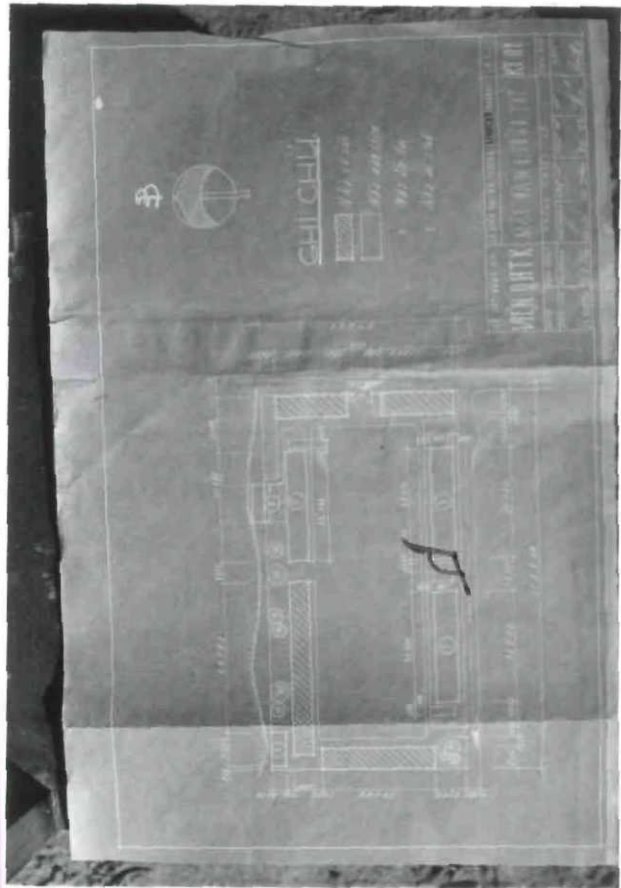
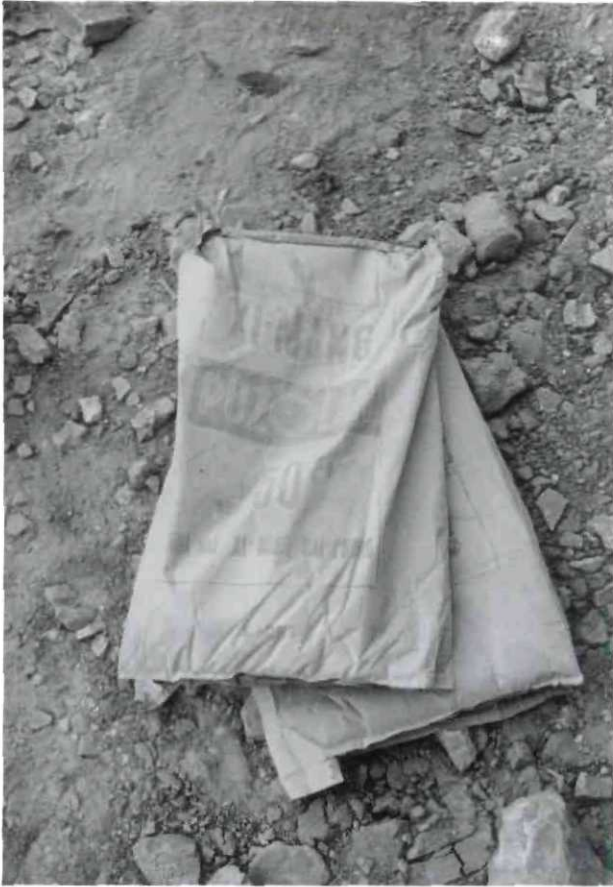
Above and below: Mortar and concrete is mixed by hand. The cement was of local brand - produced just across the road at the Haiphong cement factory. Probably it had been swapped with the cement UNICEF purchased for this project, which was partly delivered early -77 and partly detoured to Ho Chi Minh City (to be sent to Haiphong later).

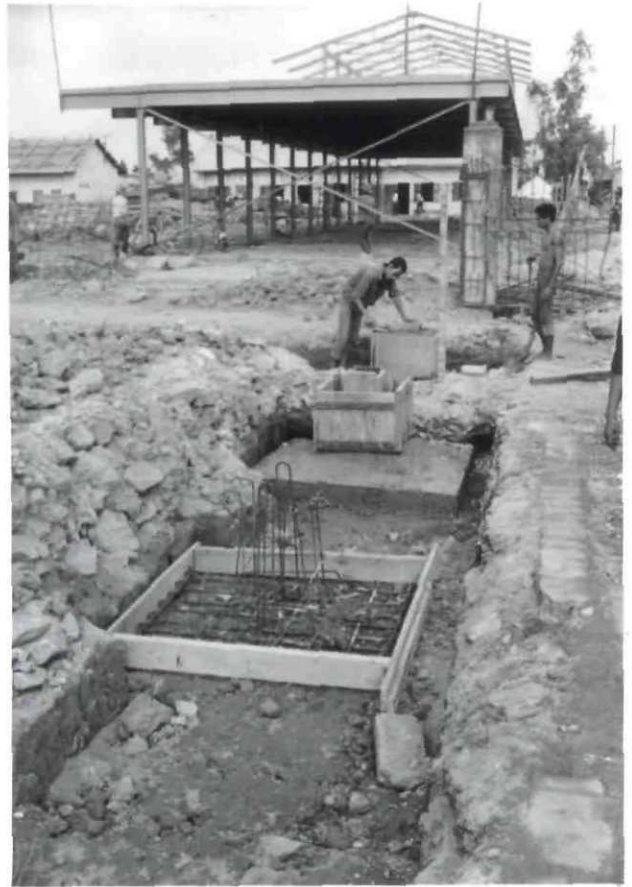
Top: Foundation design: The subsoil is first stabilized 60 - 90 bamboo piles /m², three metres long, and a layer of concrete with crushed bricks as aggregate. The prefabricated reinforcement for pillar foundations is located and bottom slab cast. Form-work for pillar hole is assembled and the hole is cast. Simple and adequate.

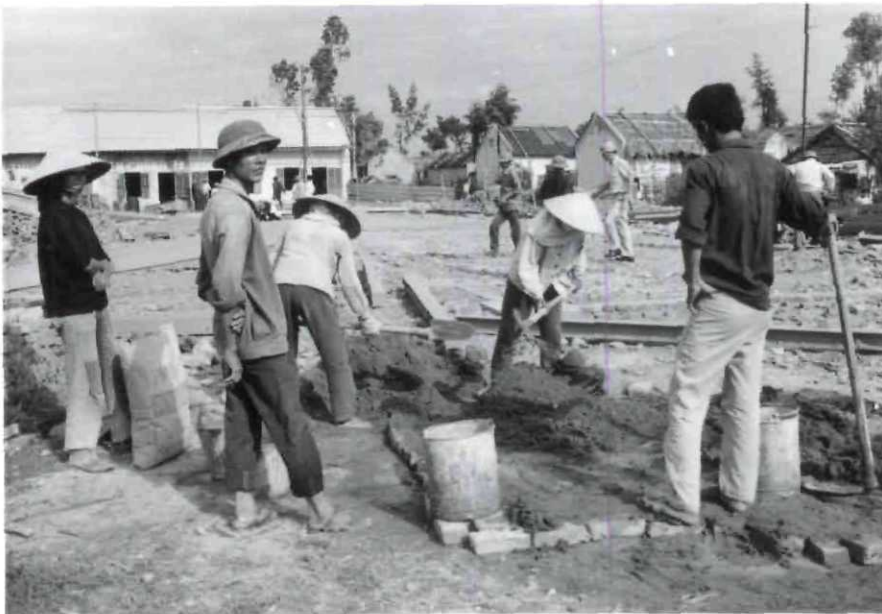
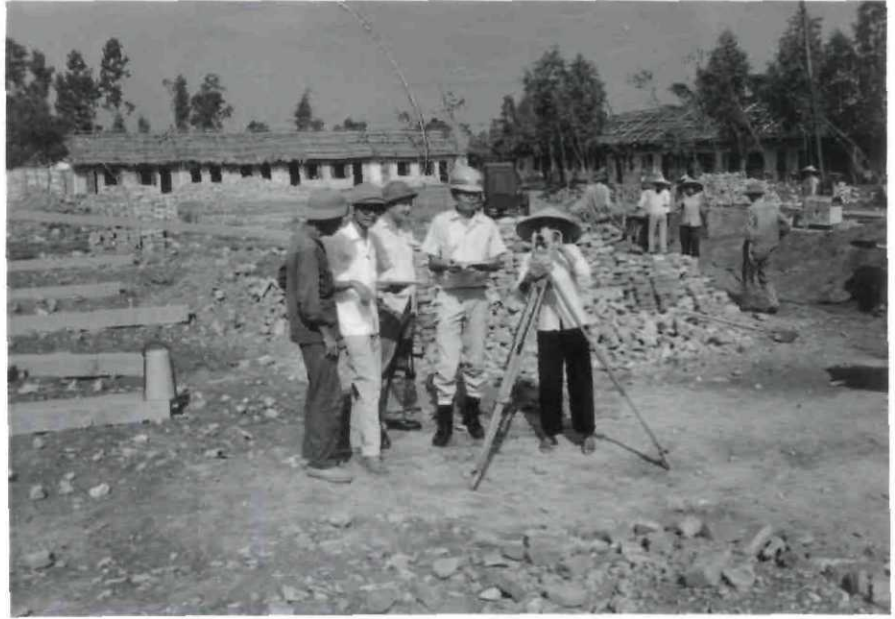
Top: The levelling of the foundation[^] was checked. The female engineer had done a good job and the levelling of the bottoms of the pillar-holes[^] were within reasonable tolerances, $\pm 11\text{mm}$, and in a fairly constant slope.

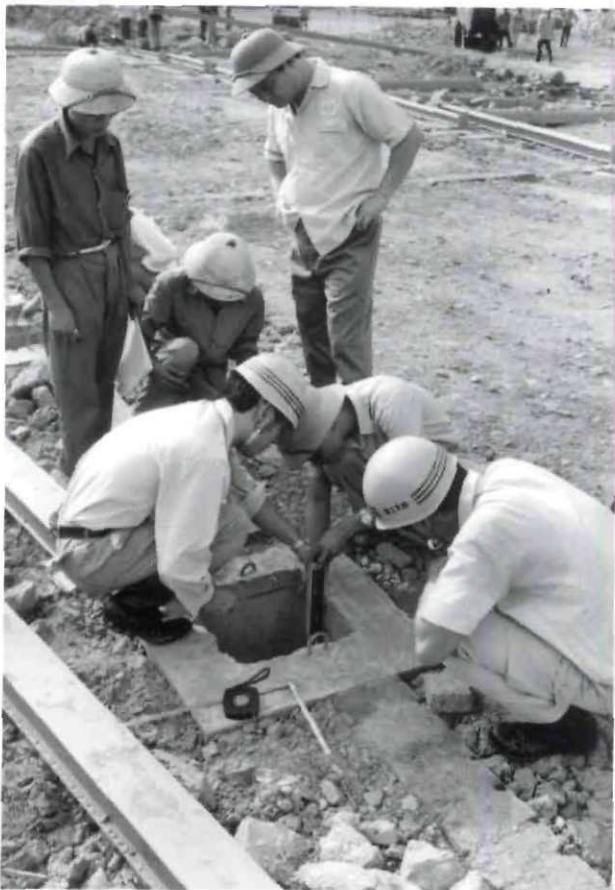
Left: All holes except one were correctly located. The incorrect one was easily enlarged.

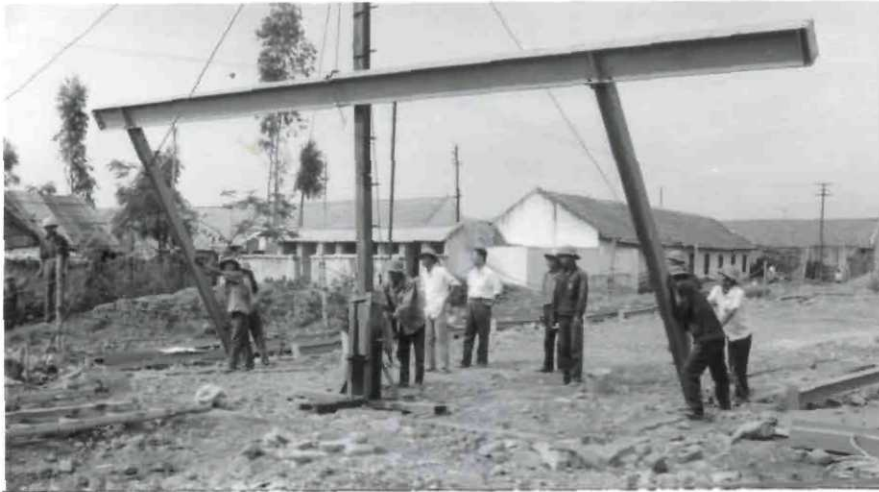
Top: The first frame is lifted into place with the help of a short gin-pole.

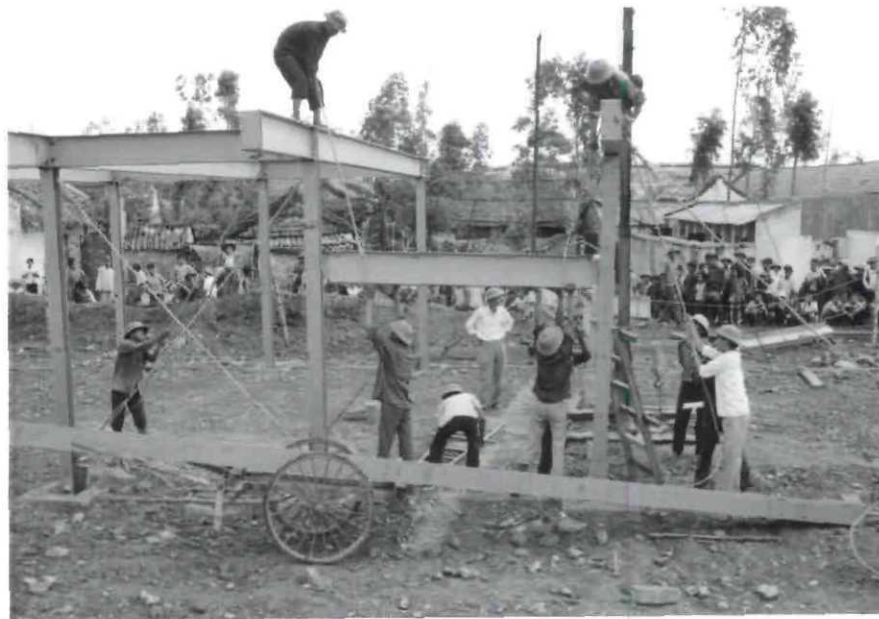
Middle: The erection procedure was improved compared with the originally foreseen. The whole ground floor was built first, then the first. Thus the gin-pole could be half the size of the one tried in Japan. No units had to be lifted more than one storey.

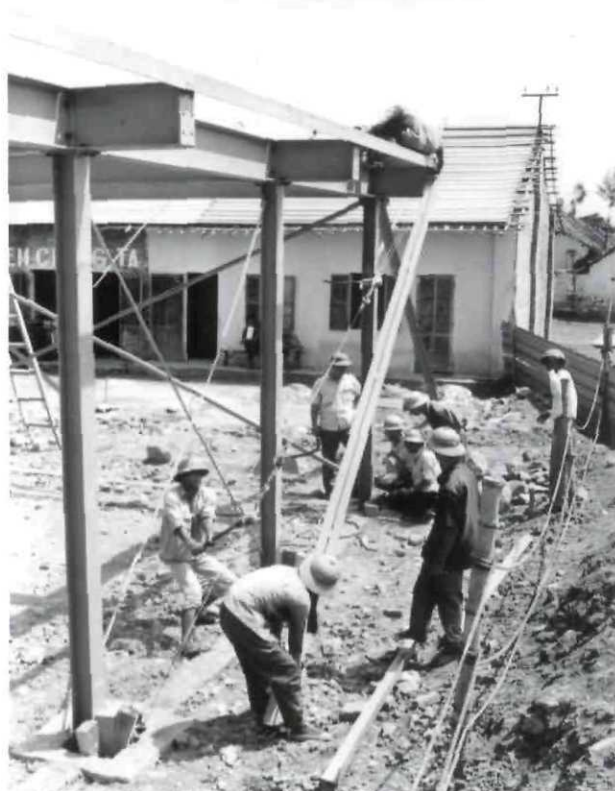
Left: The structure was ingeniously temporarily staged by using units to be used later. Here, no P8 (roof truss bottom chord), is being bolted to the beam P5A. A small jack is used to adjust the perpendicularity.

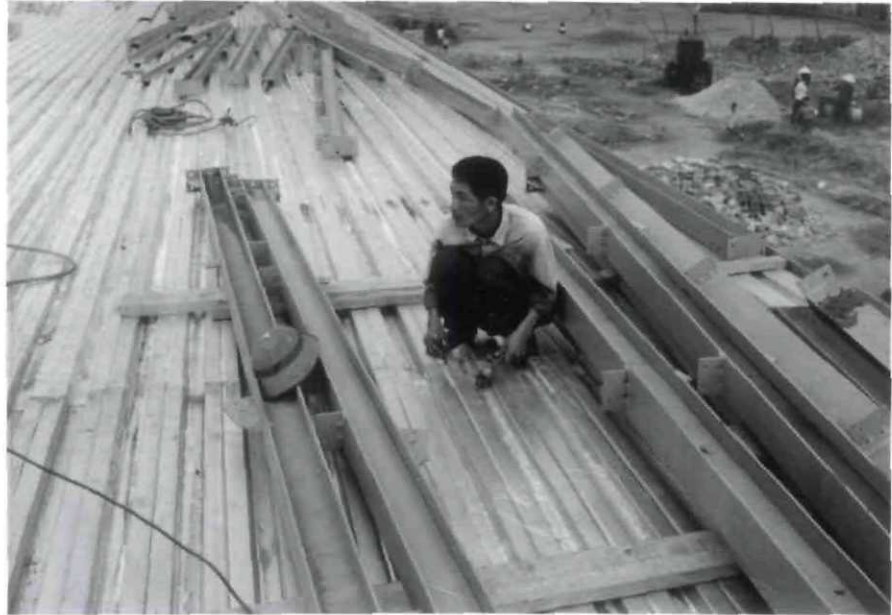
Top: The steel deck was installed very quickly. Holes for the first floor pillars were not pre-cut on the ground as originally intended. They were chiseled out on the spot - a good method reducing the risk for errors and gaining time.

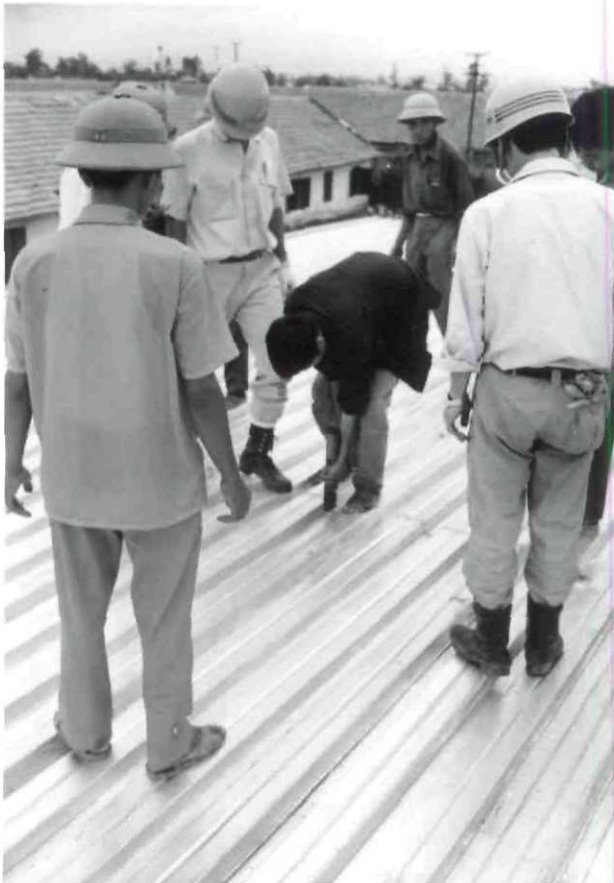
Left: The Hilti rivet gun in action. It could however be born in mind for future projects that guns and cartridges are difficult to ship together due to the restriction on explosives. This creates logistic problems at the receiving end why the Hilti method should be avoided. In this case spot welding can be used when available. A better solution might have been to design the structure for locally made pre-fab concrete slabs instead of imported steel deck with concrete topping. Some extra reinforcement bars could be procured instead.

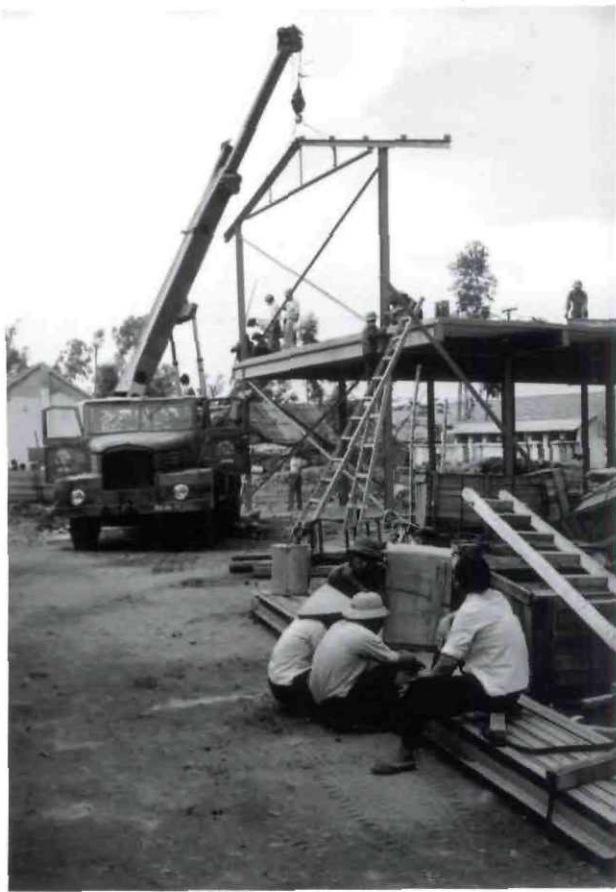
Above. The first frame on first floor was erected with the help of a crane. It could just as well have been done with a ginpole, but the lorry was at hand unloading door crates. In front engineers are discussing the designs.

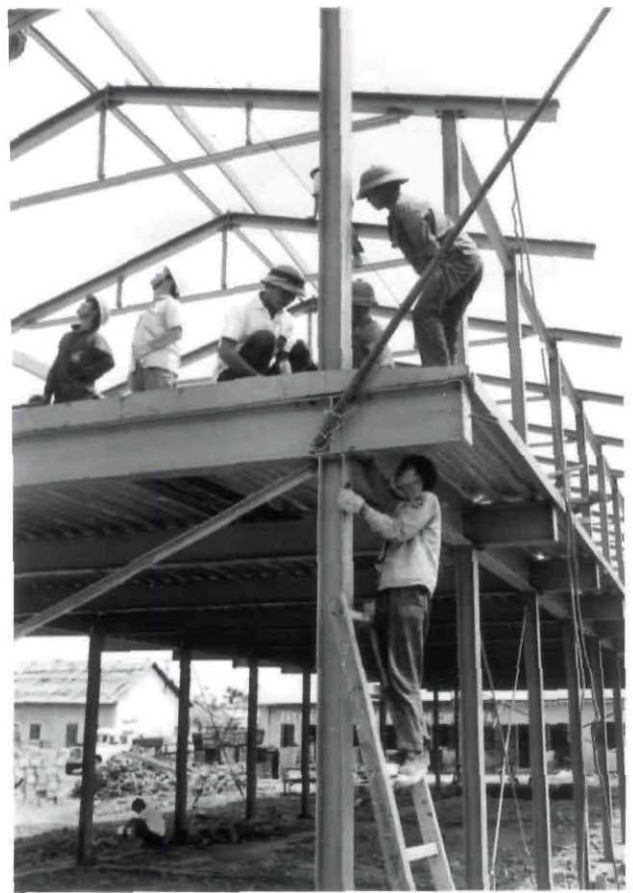
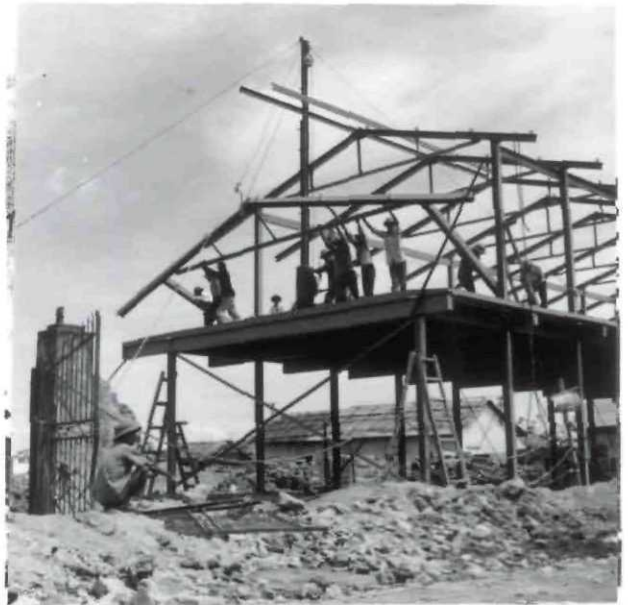
Above and below: The last frame on first floor lifted by the ginpole and bolted into position.

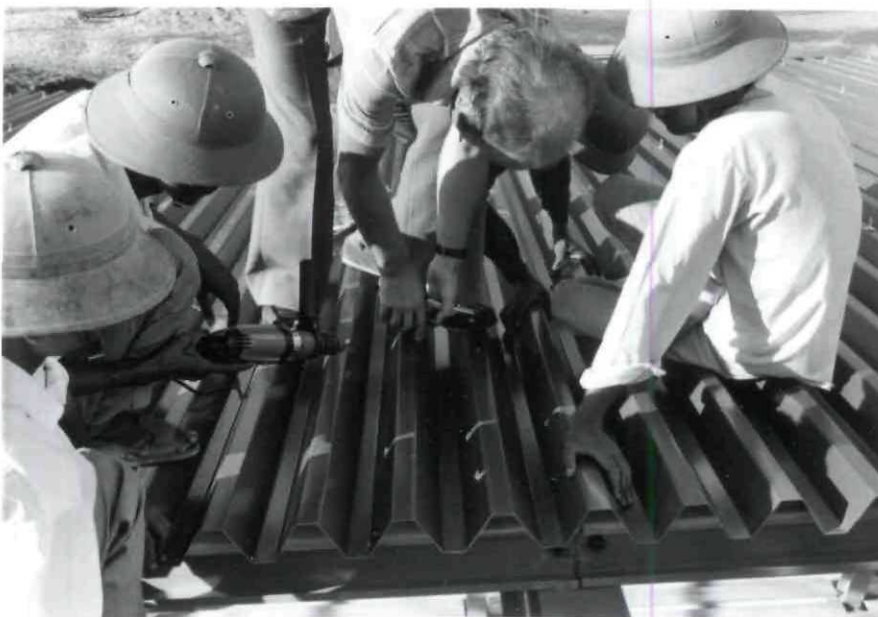
Below left: Advising on riveting technique. Mr Clarke is using my pop-rivet tool since the Speed-T-Rivet tools provided by UNICEF were not yet available at the site. They had been packed ten in a box for each batch (33/34 buildings). This creates distribution problems. In remote areas, which buildings are not to receive rivet tools? One tool per building would have meant only a minor extra cost and avoided many problems and risks of errors. The Ministry of Education promised however to look into this problem with extra attention.

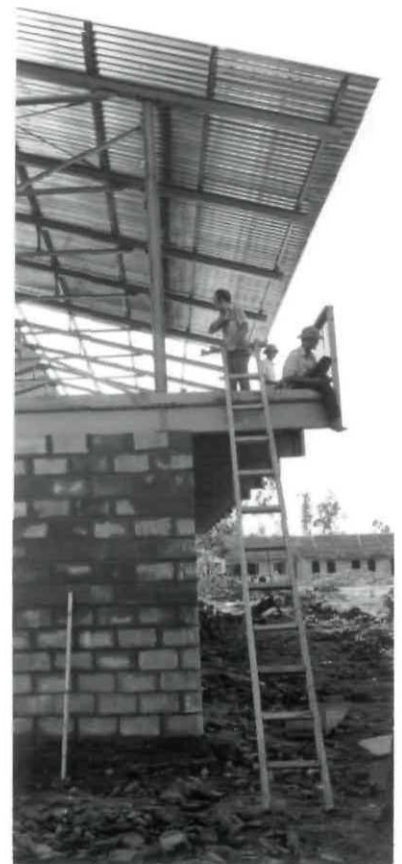
Below right: The roofing was installed with great speed and very good accuracy.

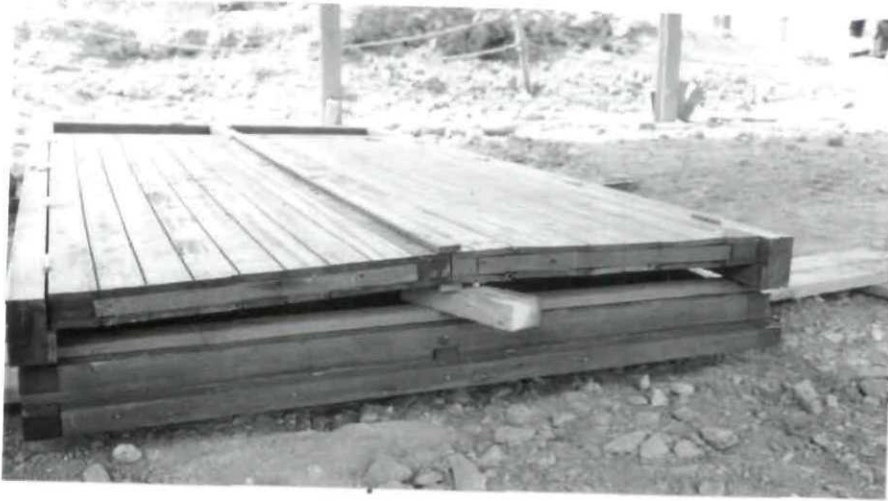
Top: The doors are heavy and difficult to handle. No threshold is included in the design.

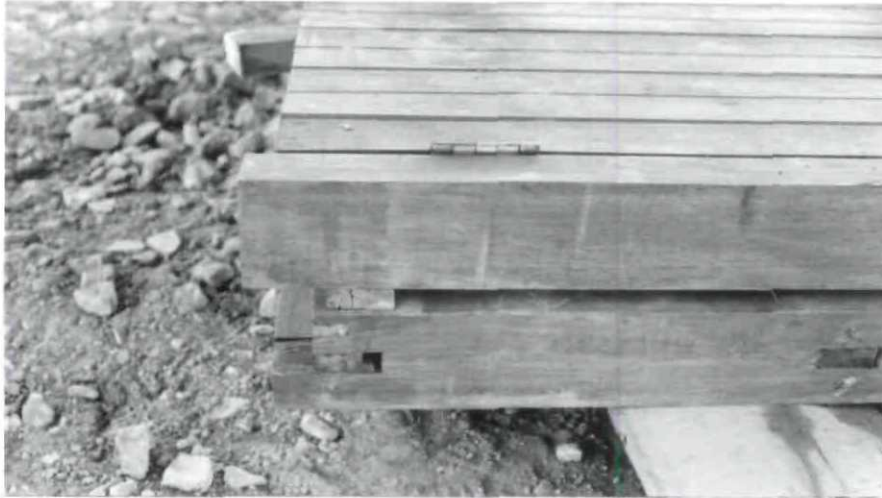
Middle: The joints are crude, sanding and pencilshaving has not been done. A reinforcement bar has to be added at the bottom of the door posts to anchor them into the foundation. If a heavy door like this is slammed, the post must be very strong and well anchored.

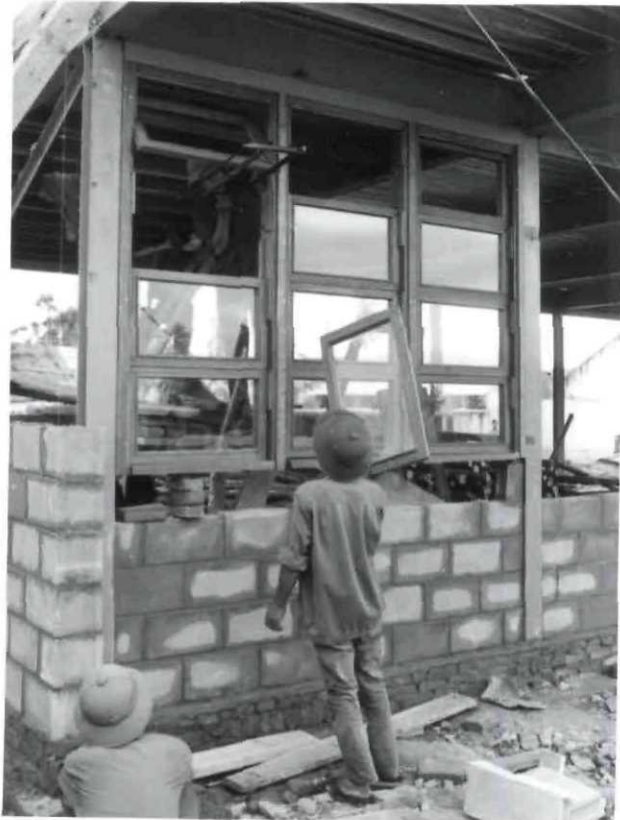
Left: The finish of the windows is like the doors. This particular frame had to be adjusted with a saw to close. However if sanding is done locally and varnish applied, they will come out all right. The wood is of high quality.

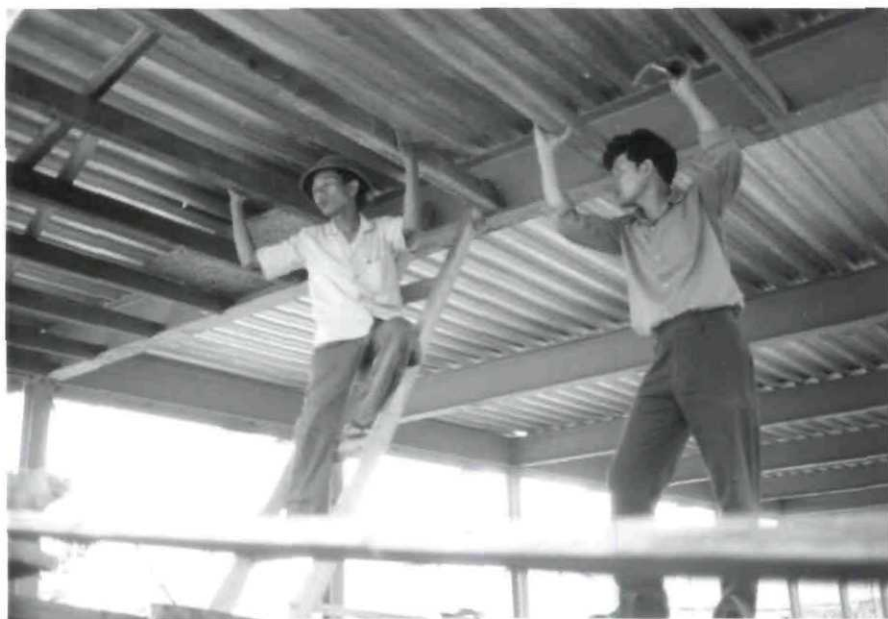
Top: The ceiling was discussed at length. Here a Haiphong site engineer (left), Mr. Pham Van Don (principal architect for the project) and UNICEF are discussing possible improvements. According to the design the ceiling boards should be screwed from underneath into the purlins. This is difficult to do and could be dangerous. The boards might fall down later. UNICEF suggested that they should be nailed on top of the purlins. This method can be seen illustrated behind the engineer. It was later agreed to change the design this way.

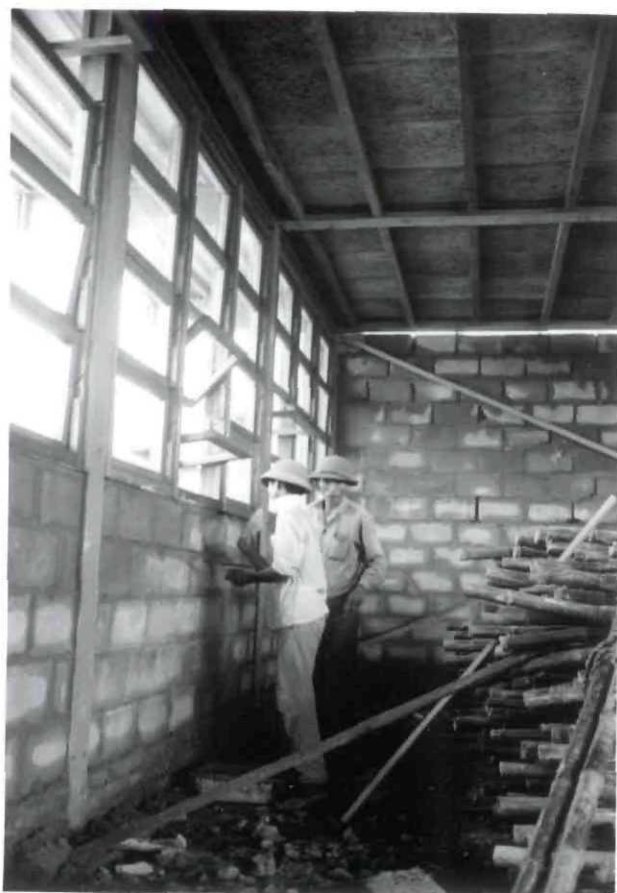
Right: UNICEF also suggested that the purlins were to be turned upside-down. Then the bead suggested by Mr. Hamel fits perfectly into the upward-facing slot at the ends of the purlins (can be seen next to the steel beam).

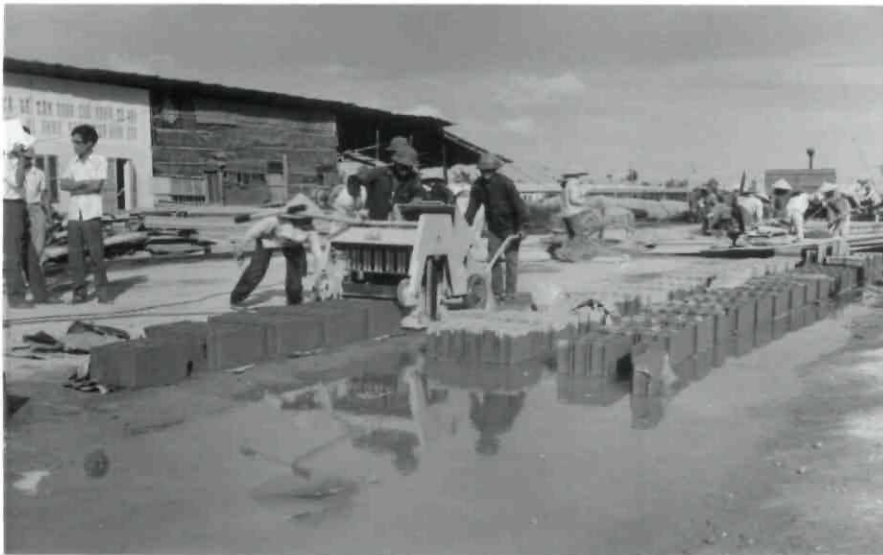
The concrete block machine at work a morning after a night of heavy rains. The concrete is mixed by hand. Due to no gravel and pebbles in the concrete as aggregate the newly made blocks are weak and some break when de-moulded. Once hardened they are perfectly adequate.

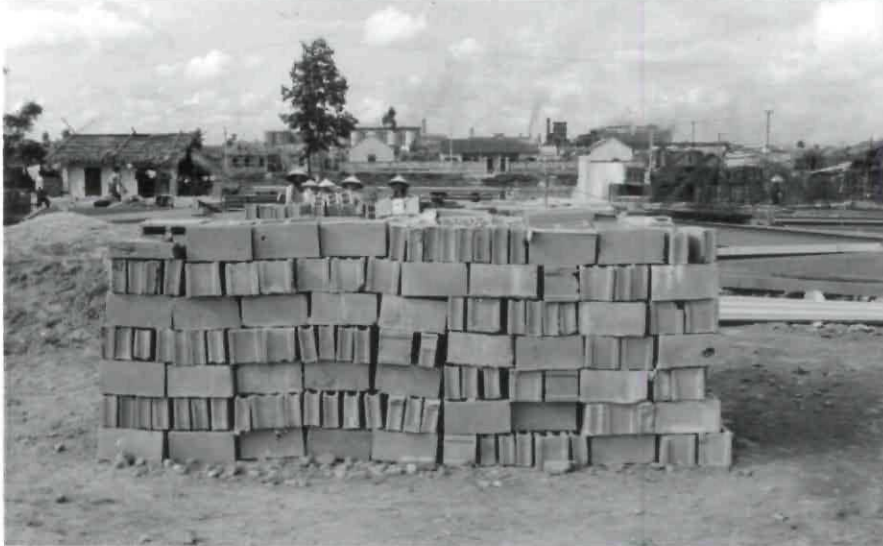
Blocks stored at the prototype site. Good quality!

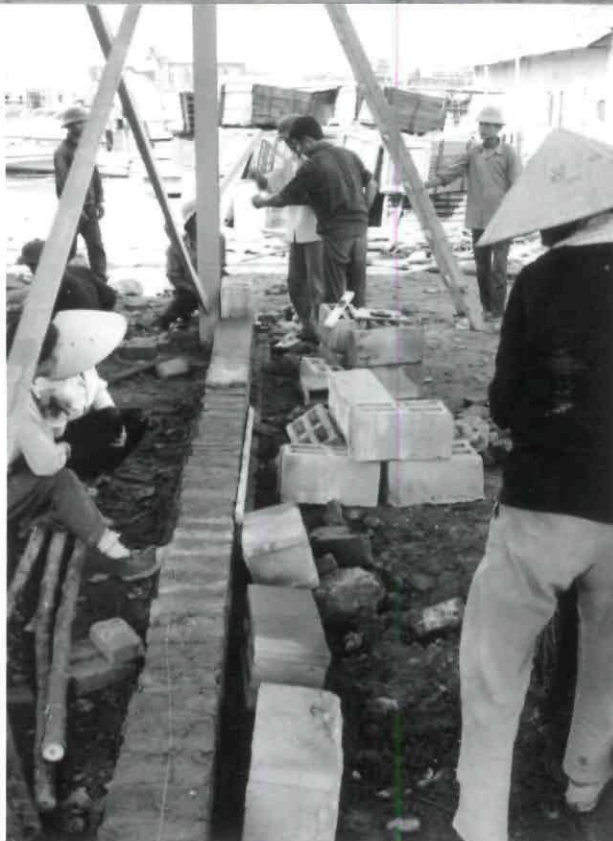
The first block is laid. The masons were very skillful. Note that in the middle of the picture, a special block can be seen. It has an extra slot in the center. It is easy to cut in two and half-blocks are needed at the ends of the wall.

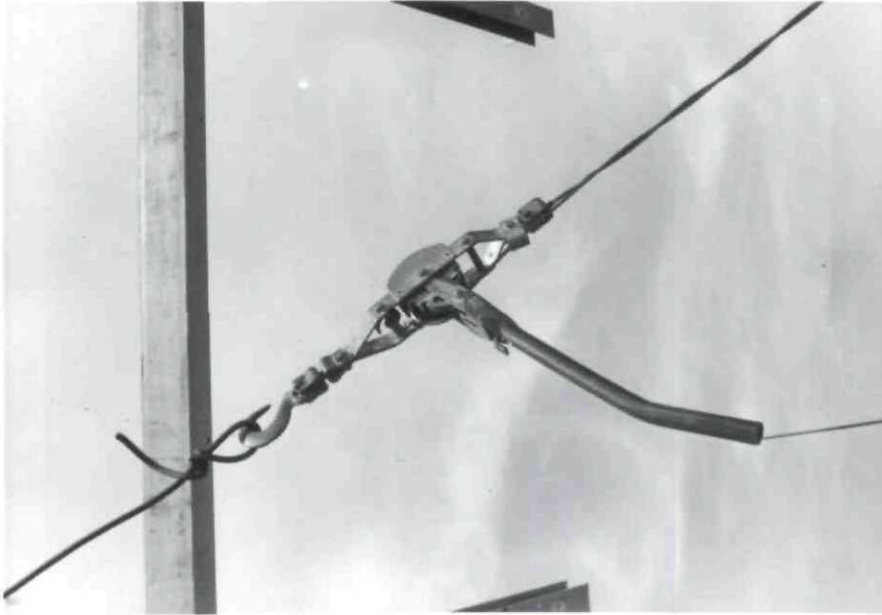
Jack, 1 metric ton.
Very useful.

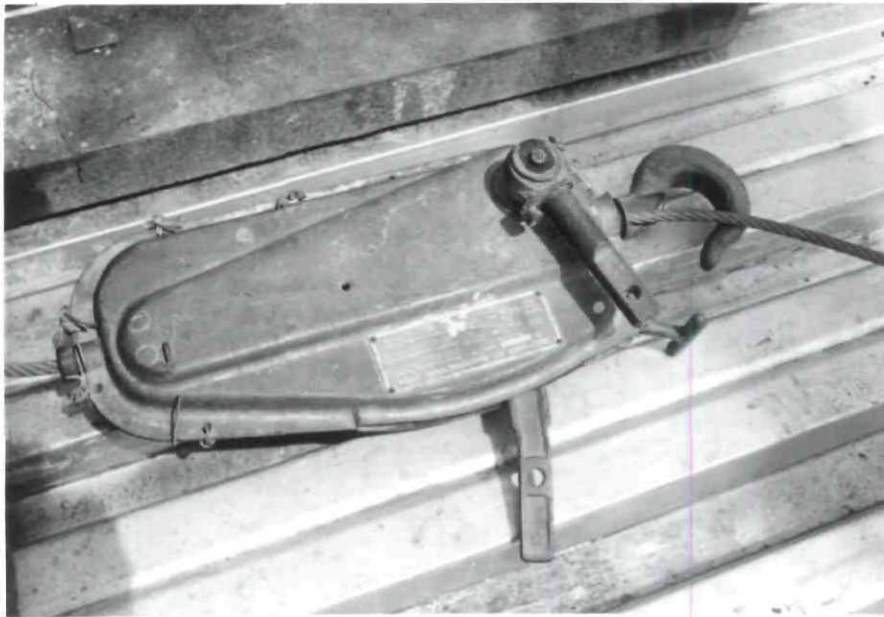
Jack, 5 metric tons.

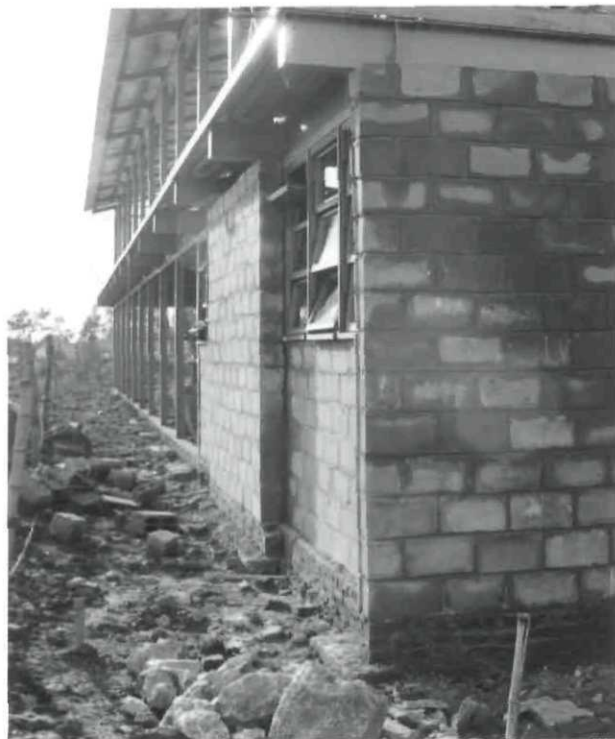
Right: The concrete blocks are very useful in Vietnam. The speed of construction is considerably faster than with bricks. UNICEF advocated that the walls should not be plastered but the joints be countersunk a little instead. Thus the wall gives a more lively impression and lime and cement is saved that would otherwise have been wasted in the plaster. The concrete blocks are durable enough (as opposed to the traditional bricks) to withstand rain and wear without plaster.

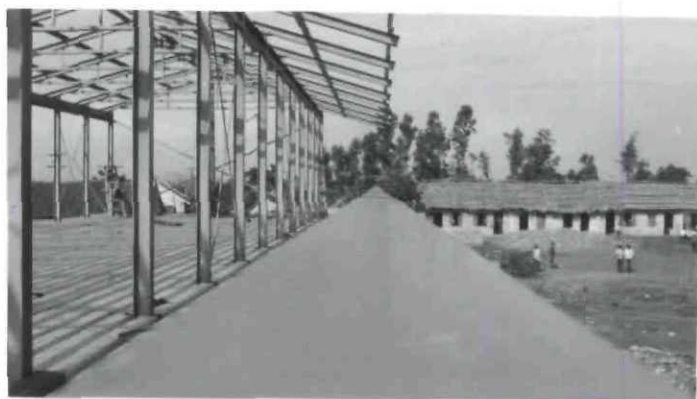
Left: The steel structure was very accurately made and well assembled. Here 33 metres of balustrade - straight and nice.

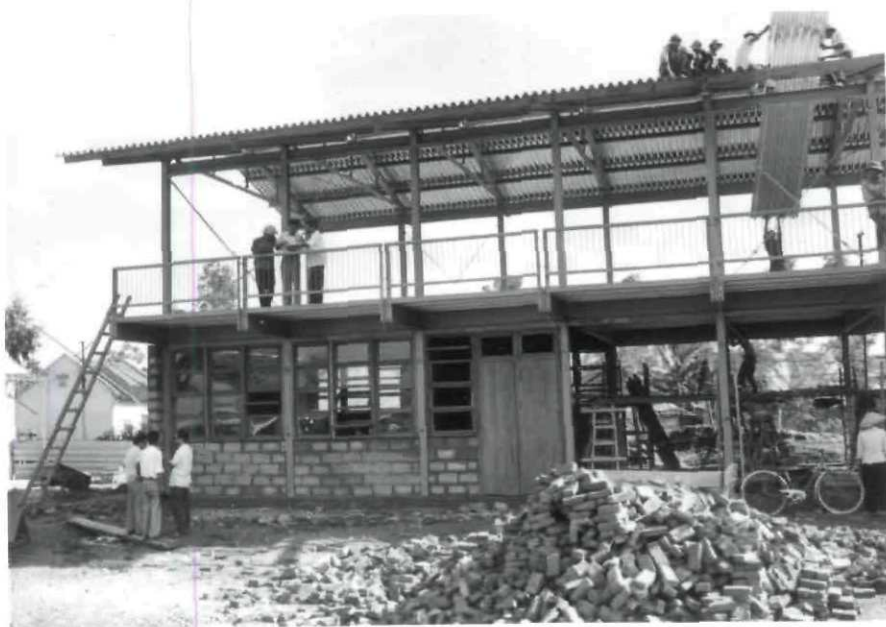
Right: The state of the prototype building at the day of UNICEF's departure. Except for the sun-sceen, all major units had been tried and found compatible although some with minor improvements.
